CHAPTER 8

DISCUSSION AND CONCLUSIONS

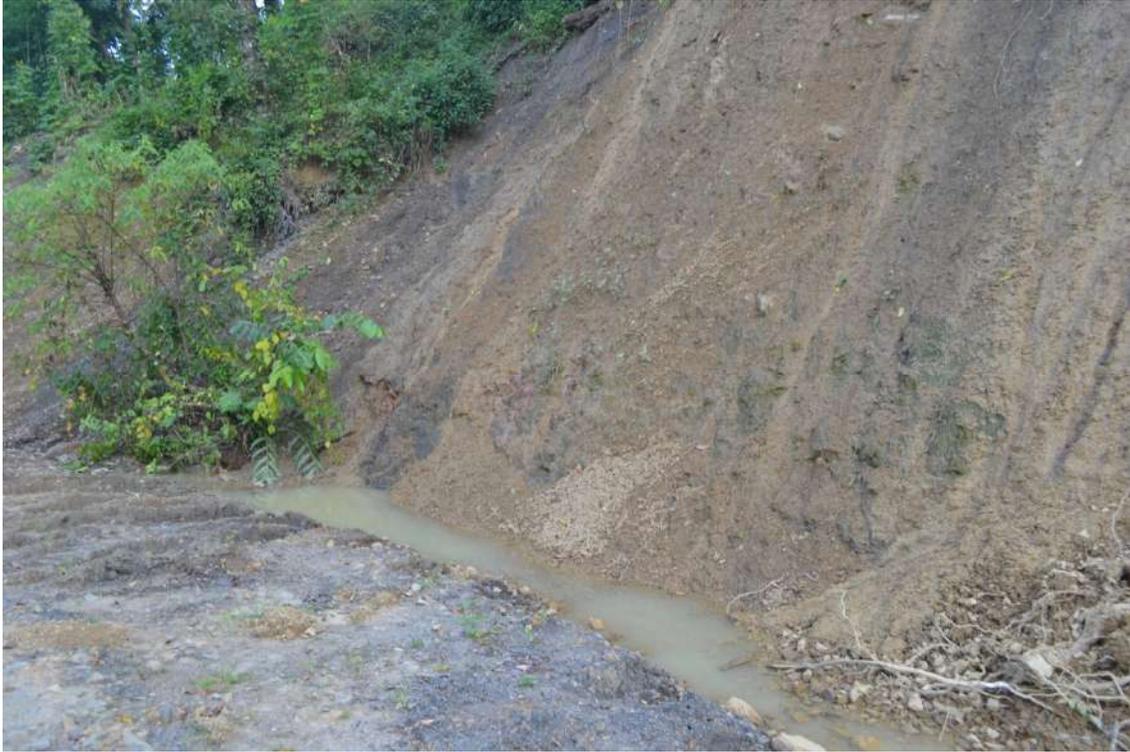
Plate 7.2.2.b Concentration of sub-surface water

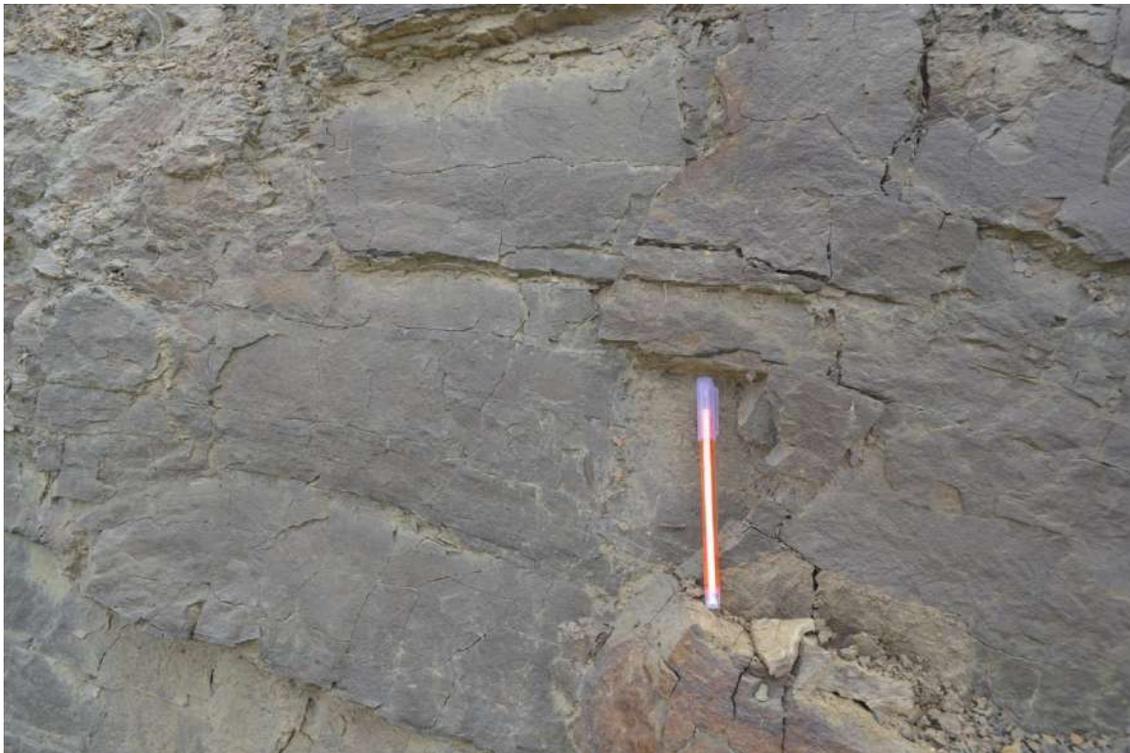
Plate 8.1.a Joints in Sandstone

About 90 percent of Nagaland state is ornamented with hills and for the most part the rocks are highly deformed due to under-thrusting of the Indian plate below the Burmese plate. These deformations are distinct in the form of folding, faulting, shearing and a number of jointing (Plate 8.1.a). Also rapid weathering continues to damage the already weakened rocks as the region receives abundant rainfall. All these factors together add a major role in generating instability in the study area or the region as a whole.

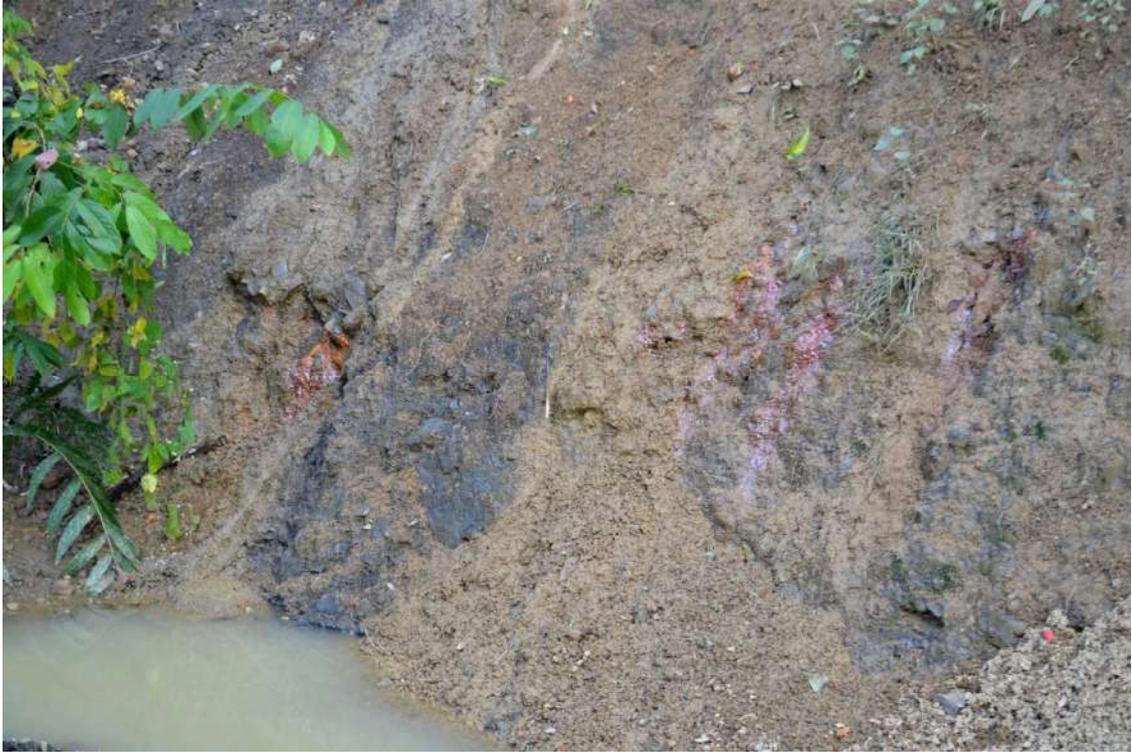
Plate 8.1.b Leaching of Iron oxide

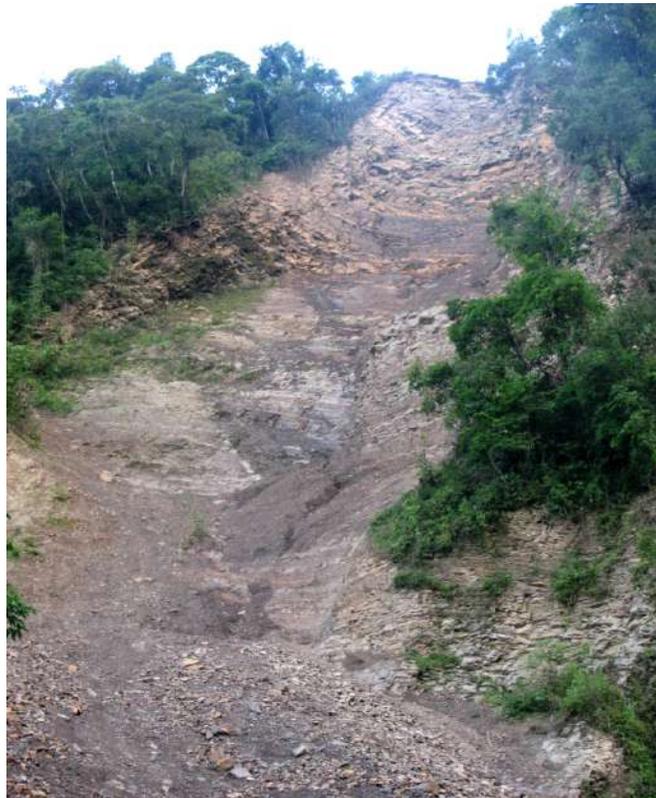
Plate 8.1.c Rock Fall

The study area is embraced by jagged hills of Upper Cretaceous-Eocene argillaceous sediments of the Disang Group and some younger arenaceous Barail of Oligocene age. They show signs of concretionary structures and box-work weathering. They are also highly jointed, folded, and faulted. The Disang rocks are mostly shales with well bedded siltstones and sandstones. Reddish brown colouration is noted in places due to leaching of iron oxide (Plate 8.1.b). Common characteristic features of rich organic matter which are dark grey and black shales gets weathered to clays. On contact with water these clays turn greasy and perform as a lubricant which increases the pore-water pressure leading to inter grain friction. This exhibits loss in their shearing strength and soil structure finally gives way. The study location is along the area where the shales are highly creased and fissile due to which, on exposure to air, they disintegrate and weather easily. When saturated, they start flowing to cause debris and mud flows. The Barail rocks of the area displays thick beds of sandstones with thin intercalation of shale beds. The failing factors are added by the highly jointed and sheared sandstone beds noted along steep bedding or joint planes (Plate 8.1.c). Also the shales with their weak planes have a trend to cause rockslides.

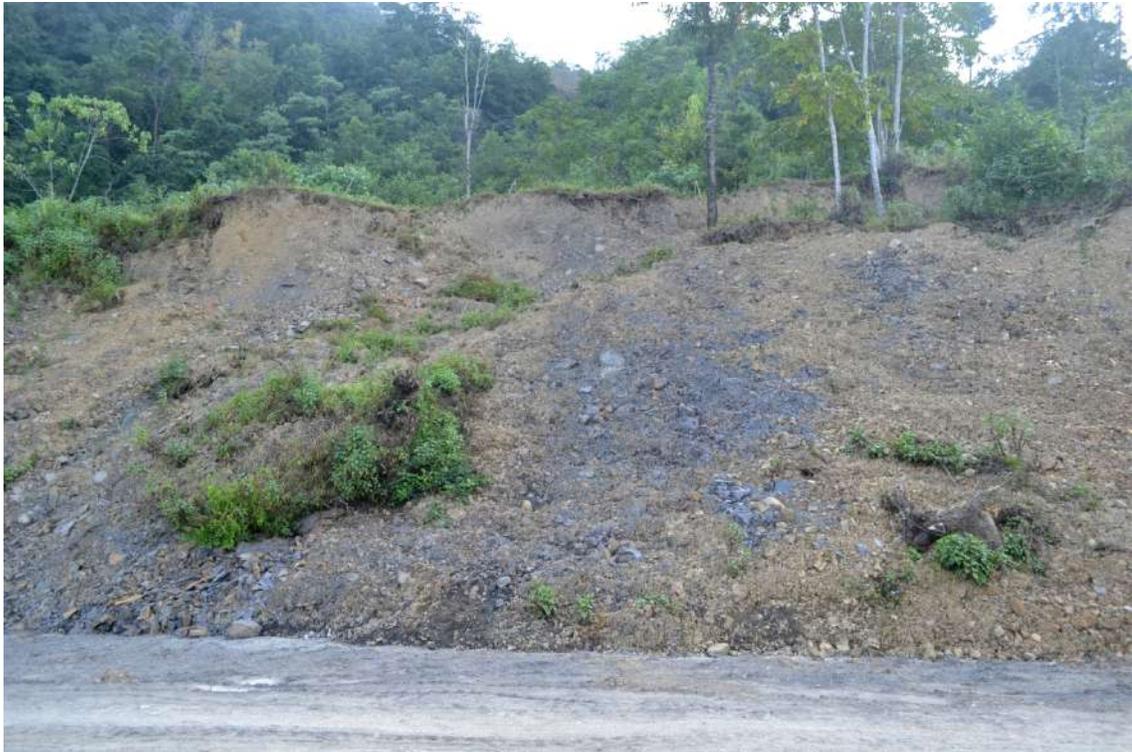
Plate 8.1.d Debris Slide along the Highway

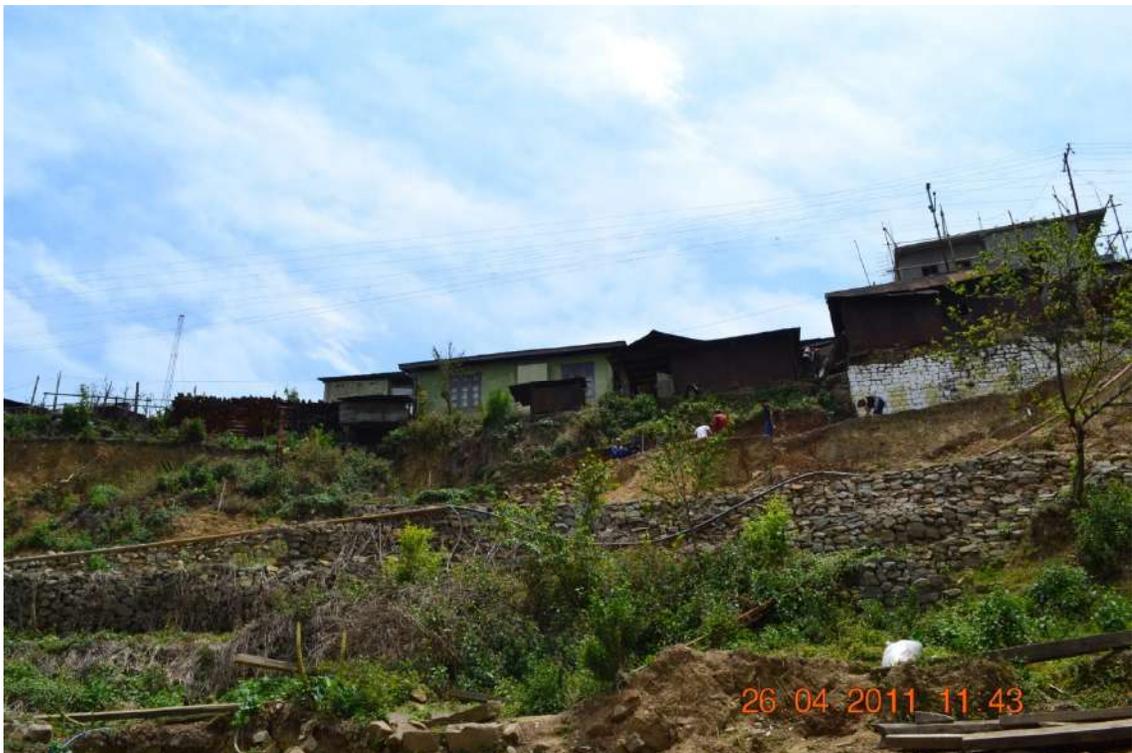
Plate 8.1.e Landslide inside the village

Land use / land cover has been conveniently classified into five categories. Some small villages are positioned in geologically uneven areas and as such these areas suffer constant landslide (Plate 8.1.e). Furthermore, haphazard earth cutting and unscientific land use practices for construction of large and heavy structures results in instability. A large amount of wet cultivation for paddy is interconnected to old landslides as the water retention during the growing season increases the pore-water pressure continuously resulting to subsidence and/or damage to hill slopes and roads. In the lightly vegetated areas, the soils are usually lean and lack cohesiveness and hence do not sustain flourishing plant life. Such areas are normally prone to landsliding and have been involved in about 50% of landslides. It is observed that moderately vegetated areas are also affected by landslides owing their cause to structural disturbances and weak lithology.

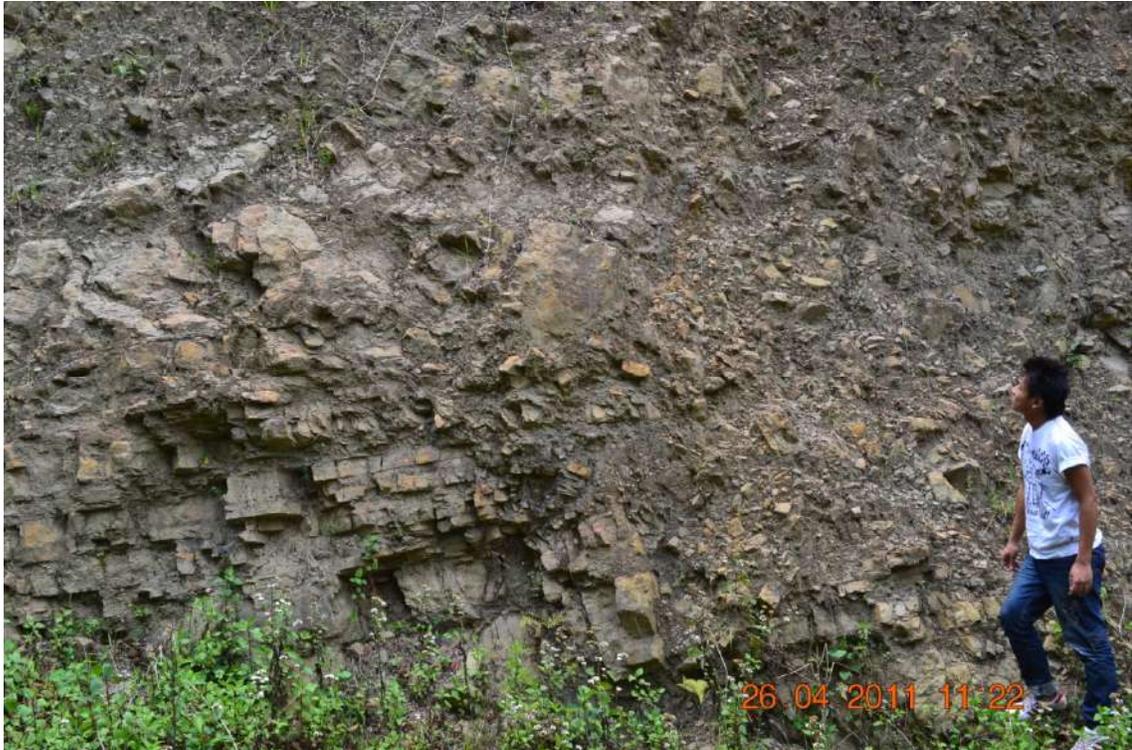
Plate 8.1.f Local fault

The tectonic disturbances in the area are reflected by numerous faults, folds riddled by a number of joints and fractures (Plate 8.1.f). Joint data which has been plotted in a rose diagram show majority of the lineaments in a NE-SW direction, which is essentially parallel to the regional trend. An additional set of joint trends NW-SE which owes its origin to tensile or shear stresses similar to antithetic and synthetic shear faults that are concentrated around the regional NW-SE compression. Due to contact of these stresses it generated hybrid fractures in the territory causing widespread deformation of the rocks. Rock falls are also dominant in vertical rock faces related to relief of the area coupled with road cutting. The shales are extremely fissile due to presence of anoxic waters (Curtis, 1980). The fissility coupled with the joint planes, have made this regions highly susceptible to mass wasting. These zones encompass varied materials that are thoroughly mixed with clayey, silty and sandy soils.

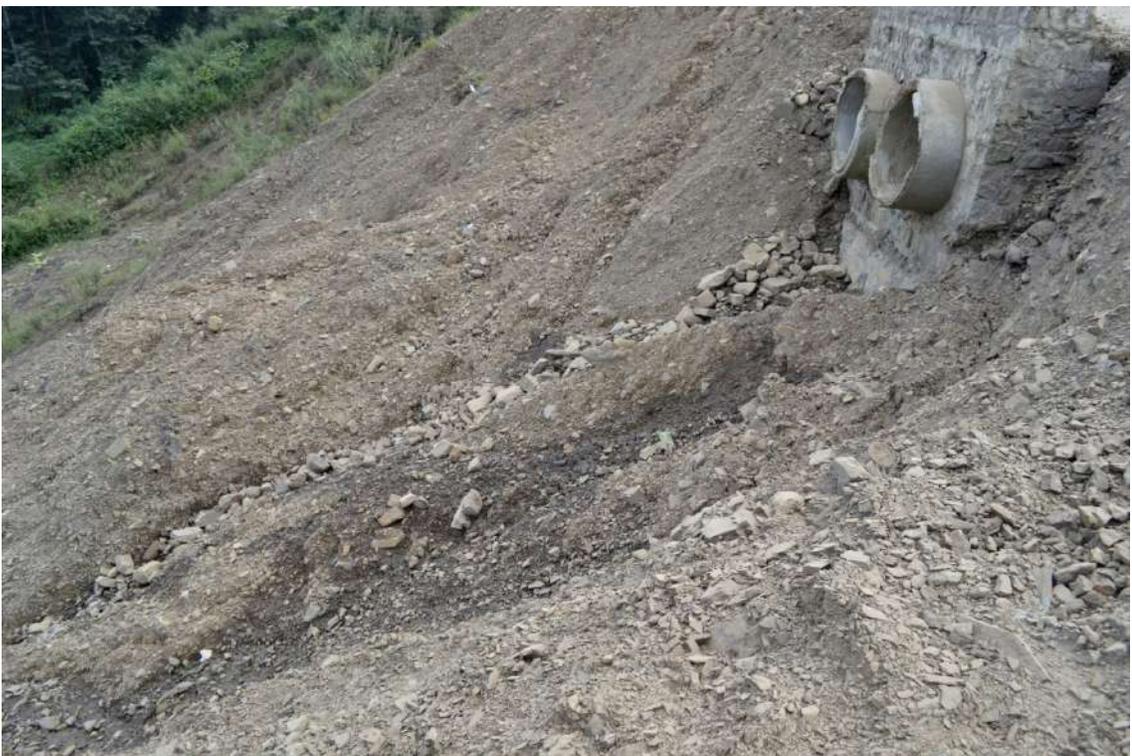
Plate 8.2 Water draining in an unstable area

Drainage system in the studied area is improper and very poorly constructed. This has led to surface run-off along the whole unstable area and also leading to huge percolation of water into the subsurface making the soil lose its shearing strength and causing failure. Therefore, drainage enhancement should include surface and subsurface clearance. To enhance surface drainage it has to take care of lined catch-water draw off above the crown of a slide, lined contour drains at different levels of the slide mass and lined cascading chutes to intercept and divert rainwater from the upslope so that water will not enter present and old landslide zones (Plate 8.2). Splashing of impermeable material like tar mulch or mortar at the crown and head regions can also be opted to shut any tension cracks and other permeable zones that provide avenues for excessive water infiltration. Such technique can help check infiltration and ease pore water pressure appreciably. Subsurface drainage development works can minimize and remove groundwater from within the landslide mass and it can lower the groundwater table. It can be of any type like the low or deep subsurface drainage control mechanism which again depends upon the nature of the slide. Some systems that can be interpolated are intercepting under drains, interceptor trench drains, horizontal gravity drains and drainage wells.
